Process Change Notice – PCN040317-01

Change to a lower viscosity epoxy material to allow the use of an automated machine instead of a manual application

We are sending you this letter and attached test data as notification of a change to Haydon Kerk's hybrid linear actuator line, specifically, 28000, 35000, and 43000 series frame sizes.

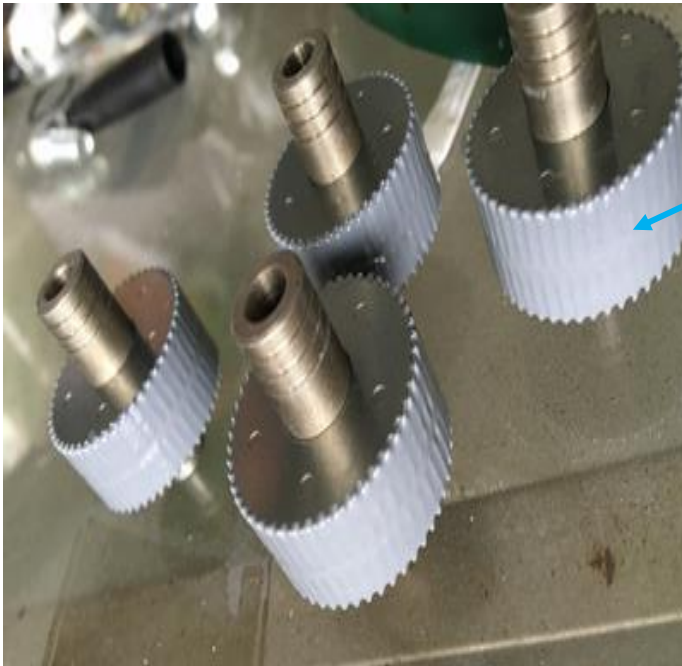
The subject material is illustrated in the photo below. During motor manufacturing, a gray epoxy is added to the outside of the magnetic rotor to aid in a final turning process of the rotor using a grinding machine. The gray epoxy is added to allow steel chips to cleanly "sheer" from the surface of the individual rotor teeth. The epoxy is used to aid in the manufacturing process only, and serves no purpose in the performance or structural integrity of the final product.

The gray epoxy material added and cured on the motor rotor just prior to turning operation

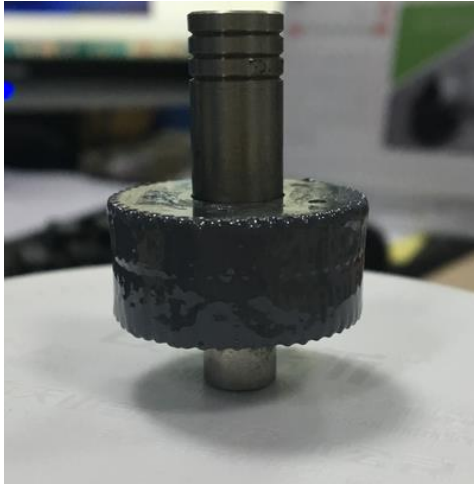
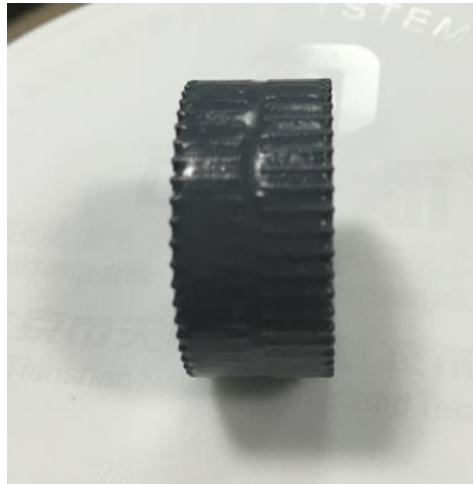
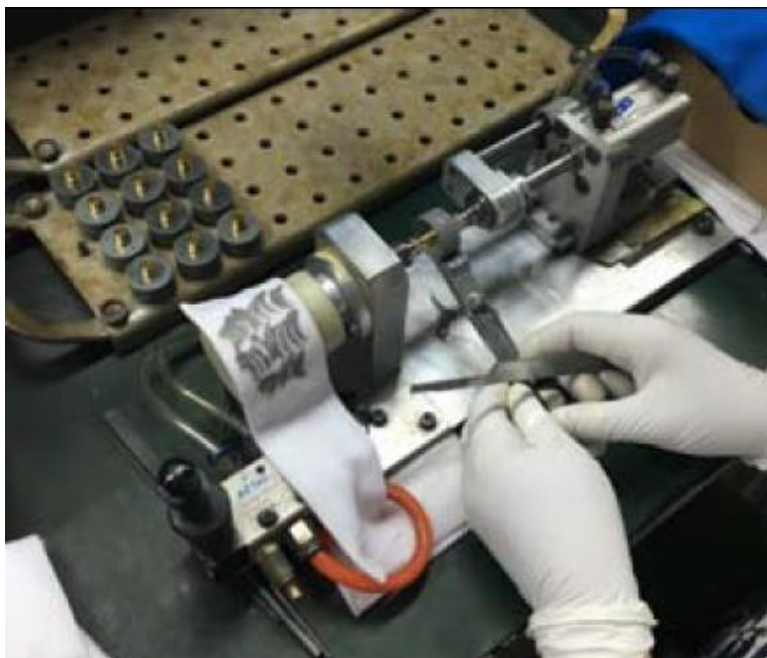
Appearance After Manual Application Using Existing Epoxy Material

The current process requires that the gray epoxy be spread onto the motor rotor just prior to curing. This is a manual process requiring the operator to add the material using a brush applicator. The new process will use an automated application machine that will increase throughput, allow higher product consistency, and result in less wasted material. Due to the operation of the automated application machine, the epoxy needed to be changed from Loctite E214-HP to Loctite E214-HP-1. The new material is a lower viscosity material that is more compatible with an automated application process. Comparison photos can be seen below.
